# **LAKE WALLENPAUPACK WATERSHED MANAGEMENT PLAN**

**December 2006**

**Lake Wallenpaupack Watershed  
Management District**

**F. X. Browne, Inc.  
*Engineers - Planners - Scientists*  
Lansdale, Pennsylvania**

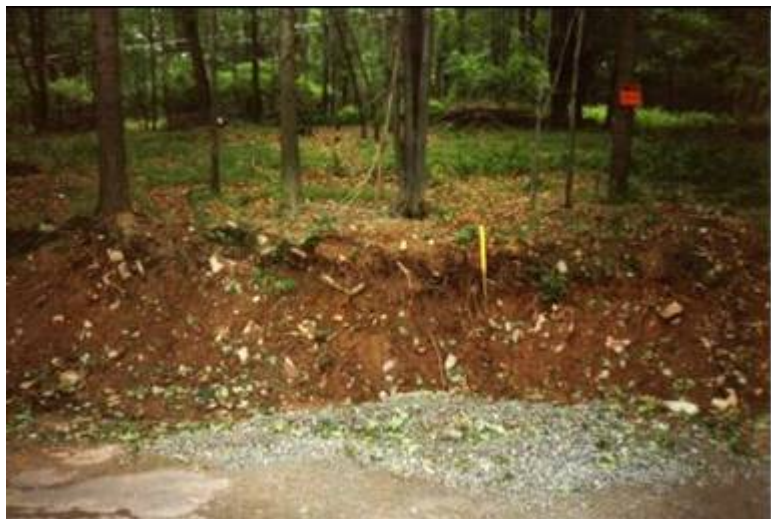
Roadside bank erosion problem area

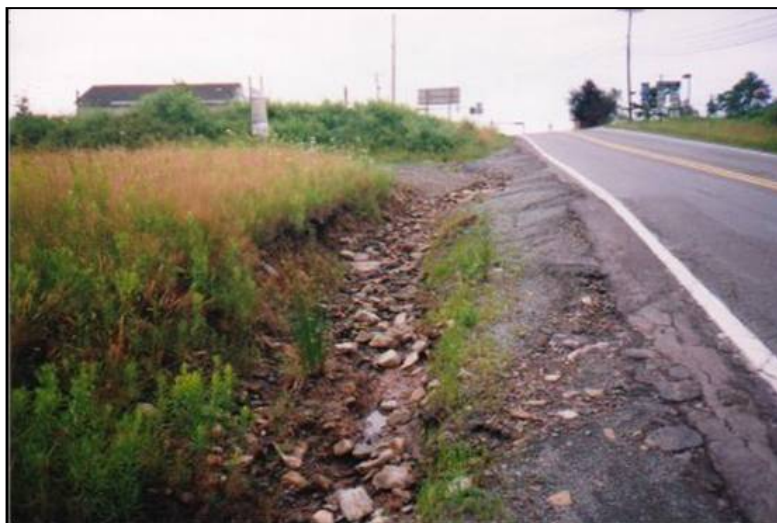
Roadside in need of repair and stormwater management

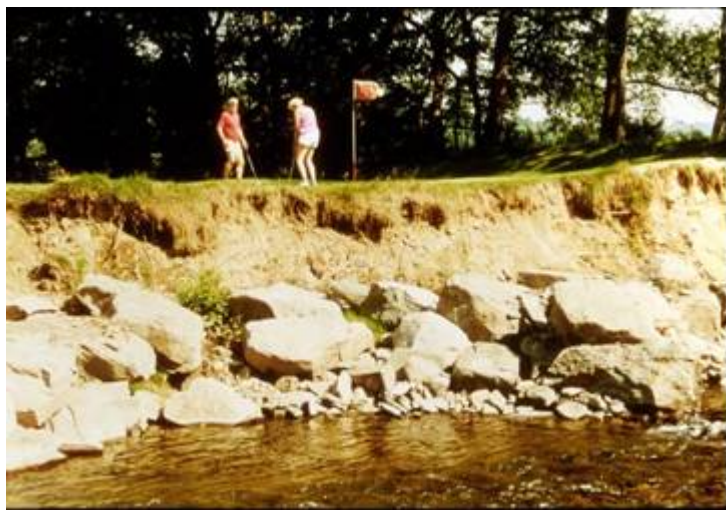
Streambank erosion problem area along Wallenpaupack Creek before restoration

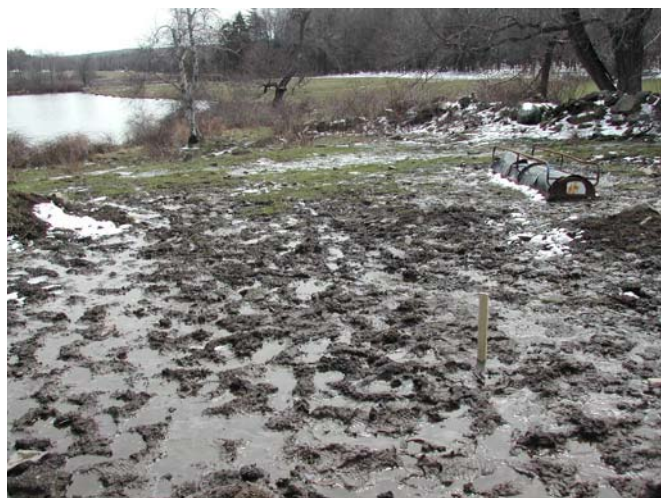
Barnyard in need of heavy use area protection

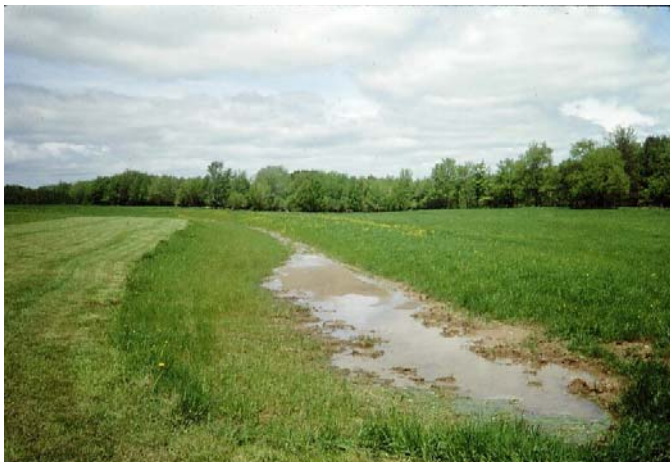
Grassed waterway installed on Kraeger Farm

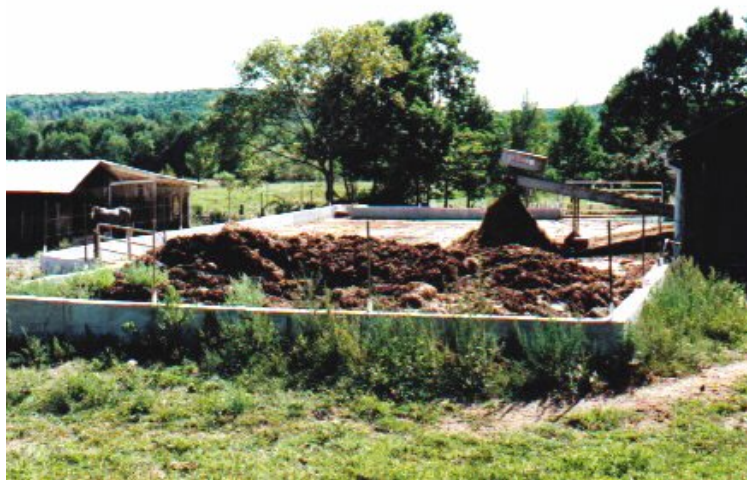
Agricultural waste facility on Held Farm, Jefferson Township

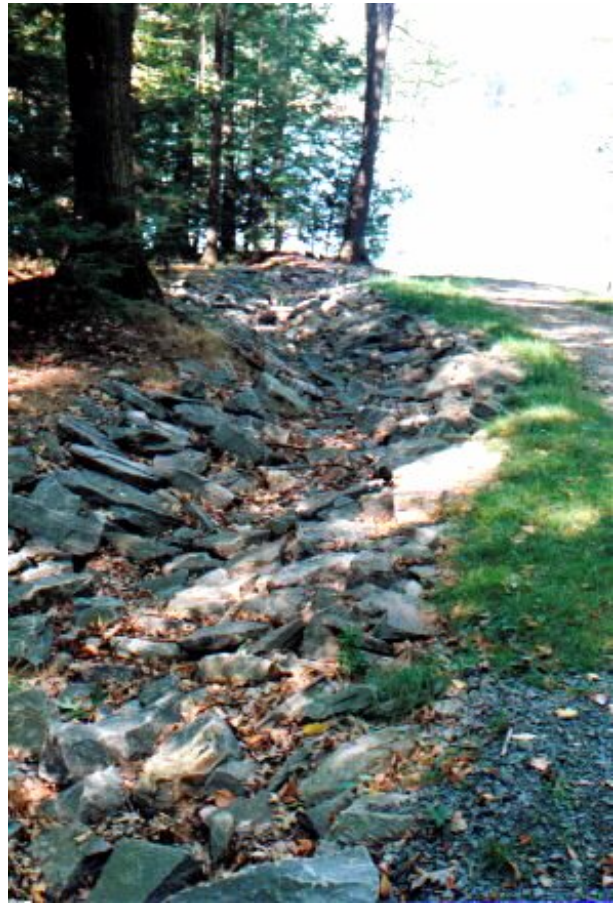
Rock-lined channel designed to reduce stormwater erosion along roadside in Paupack Township

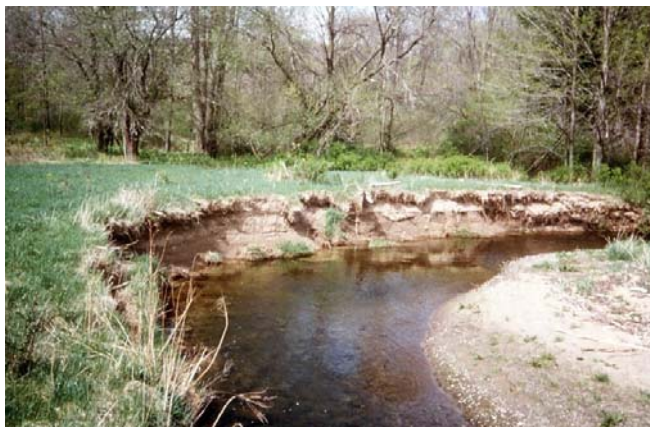
**Butternut Creek Before Stabilization**

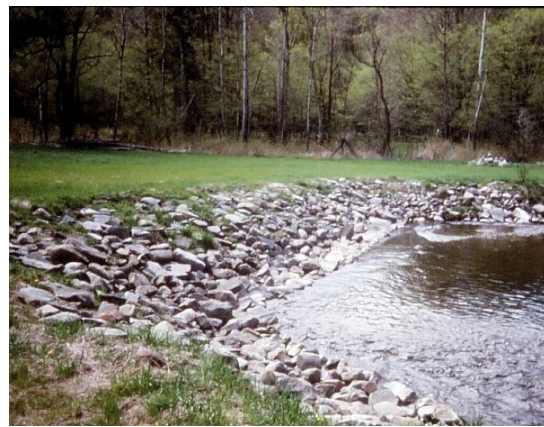
**Butternut Creek After Stabilization**

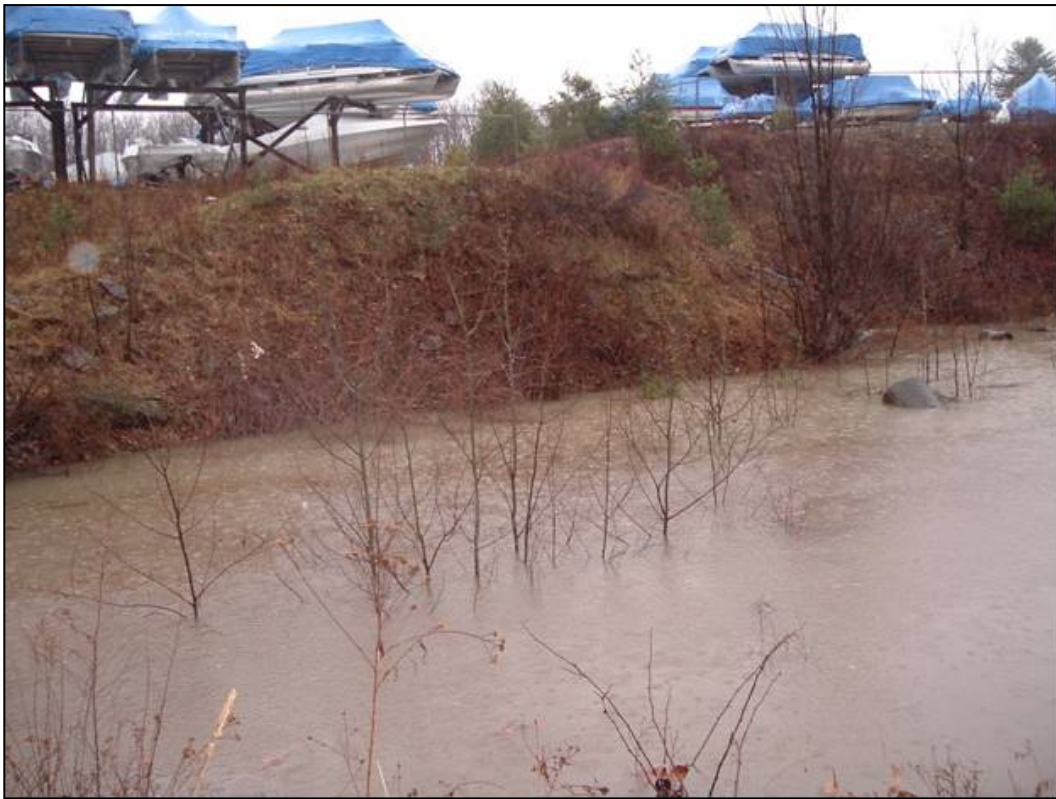
Bakker Marine is located in Paupack Township, Wayne County, PA. The marina has a large paved parking lot and covered boat storage area. Stormwater from these impervious areas was running off the site and causing erosion and flooding along roadsides in the Walt's Landing development, as shown in the photos below. A detention basin existed on the site but was not functioning properly, leading to excessive sheet flow across area fields and right into lake. Many area homes had flooded basements and property damage during heavy rains.

**Poorly-functioning Detention Basin Adjacent To Bakker Marine Before BMPs Installed**

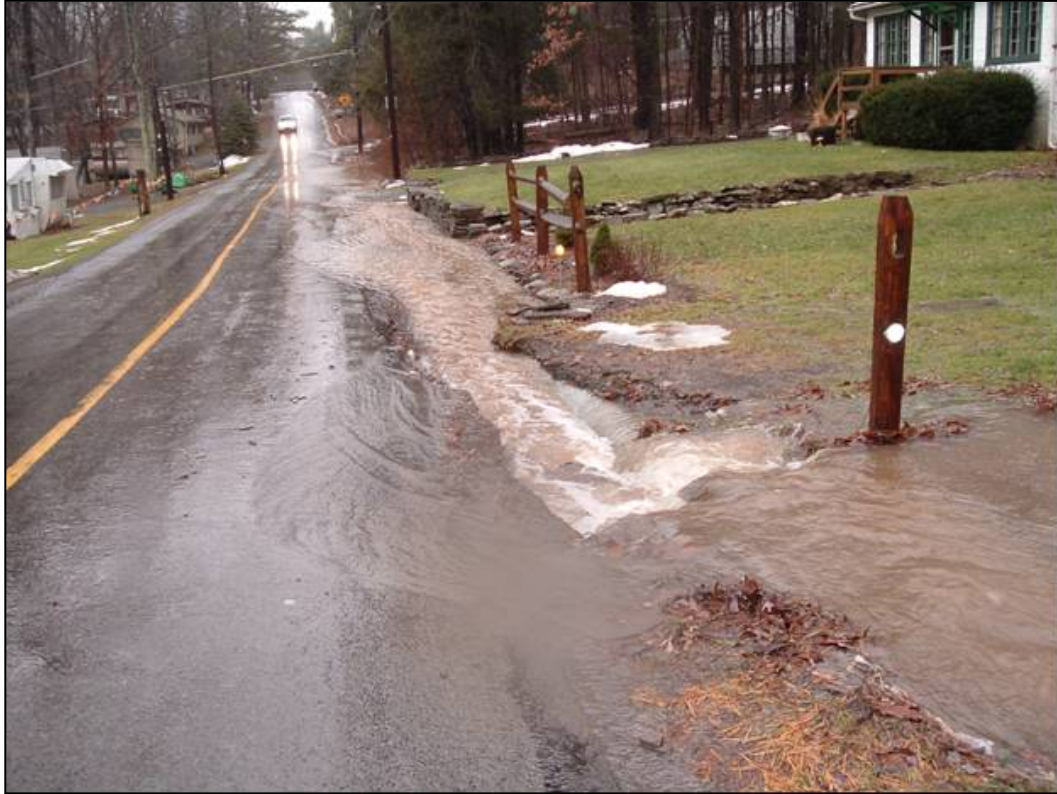
**Roadside and Flooding during rain event before BMPs installed**

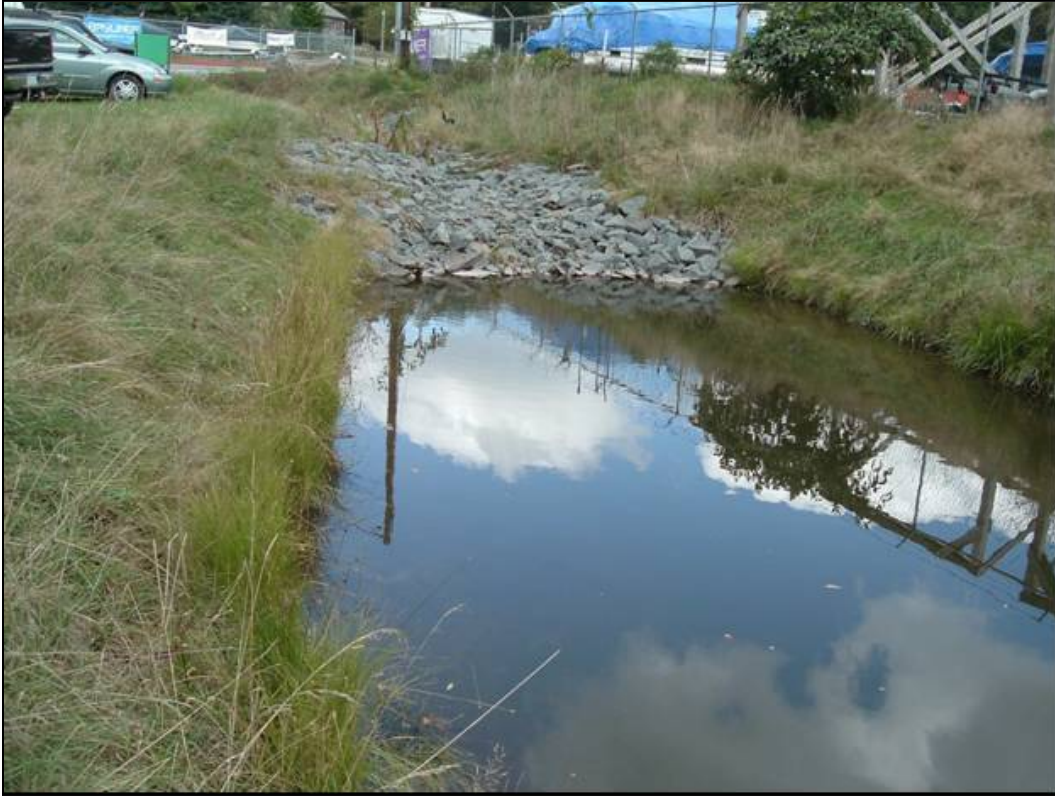
For the project, the existing detention basin was converted to a constructed stormwater wetland system to receive and treat the site runoff. The project was constructed in 2000. The wetland consists of six sediment forebays and a large basin. The outlet of the wetland is directed into a rock channel along the roadside. The goal of the BMP is to not only slow the stormwater velocity, but also to retain some stormwater for nutrient and sediment removal and peak flow reduction. The photos below show the constructed wetland post-construction and after wetland plant establishment.

**Sediment Forebay at Constructed Wetland Inlet – after BMP installation**

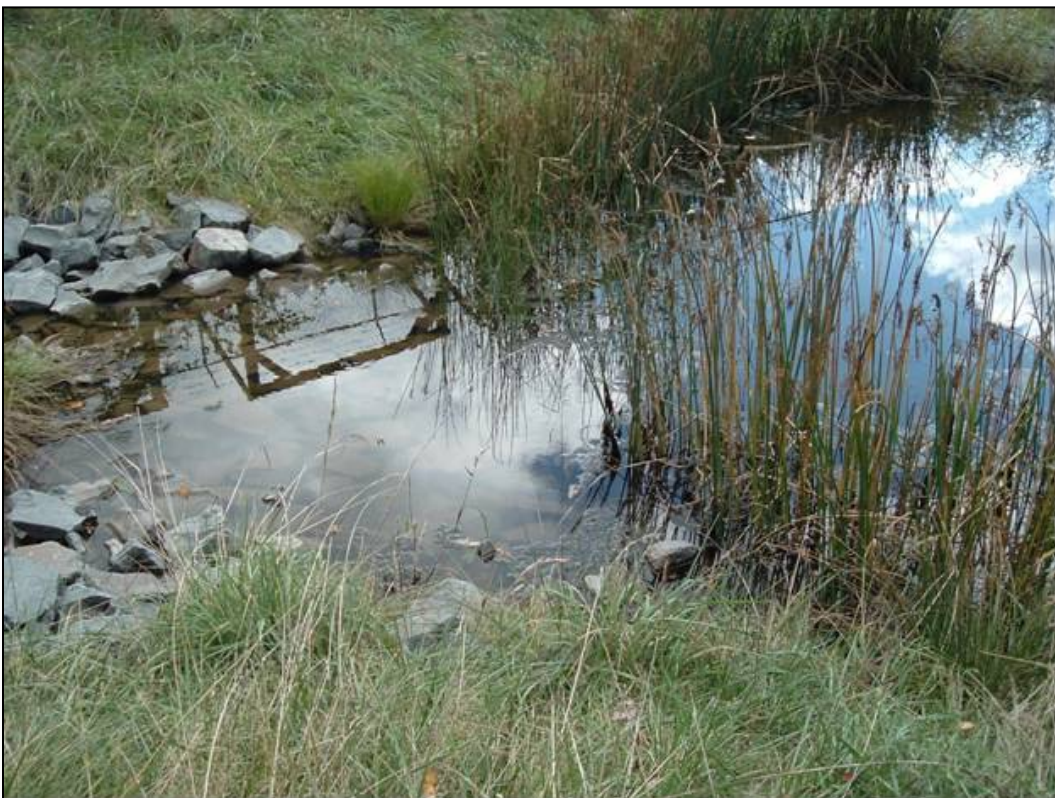
It should be noted that it took several years for the wetland plantings to become well established, but they are thriving now.

**Wetland Plantings Help Filter Stormwater and Trap Sediment**

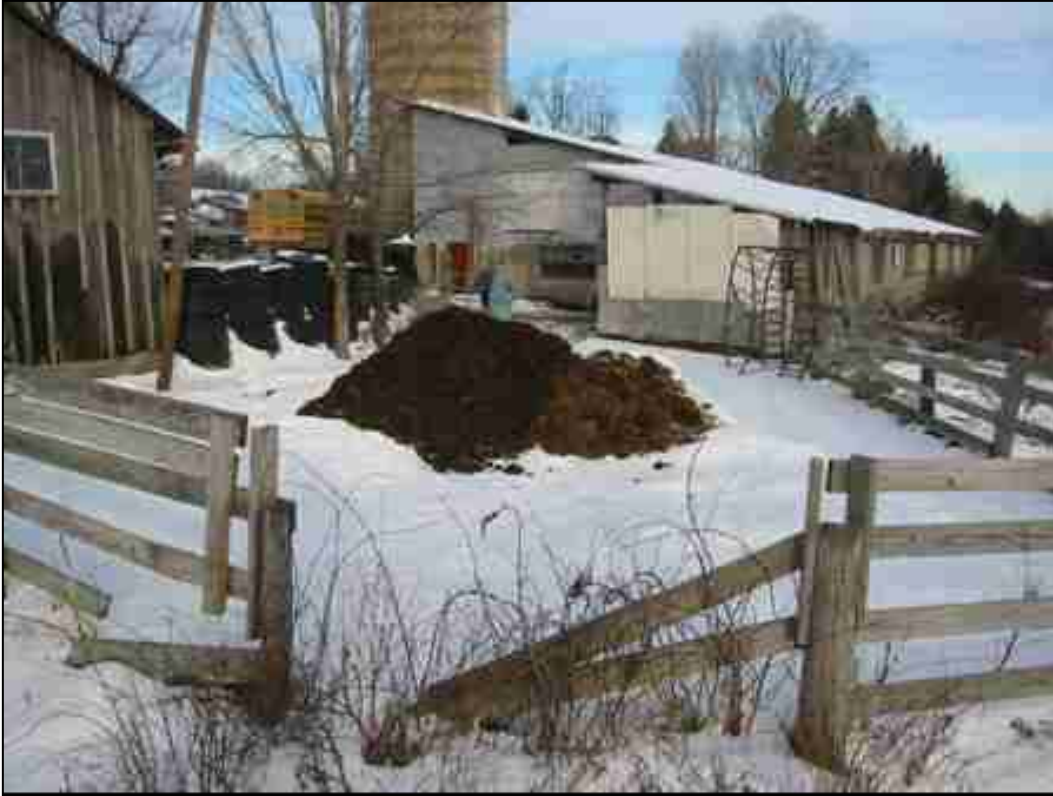
The Carroll Krautter farm is located in Greene Township, Pike County, PA. The farm primarily raises livestock. The farm had lots of open manure piles and loose soils, as shown in the photo below.

**Manure Pile in Uncovered Storage Area Before BMP Construction**

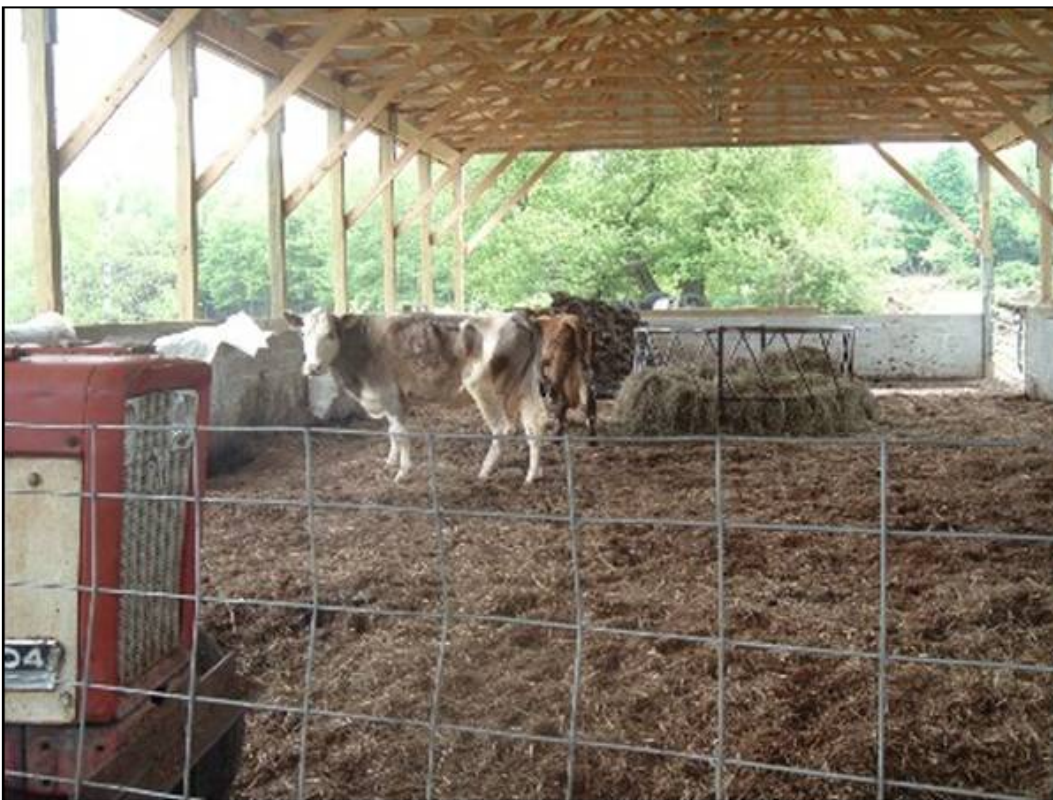
Krautter farm is located near a pond and a tributary to Wallenpaupack Creek. As part of this project, an agricultural waste facility with a roof was constructed. In addition, water diversion and heavy use area protection was installed on the property.

**Inside of Agricultural Waste Facility After BMP Construction**

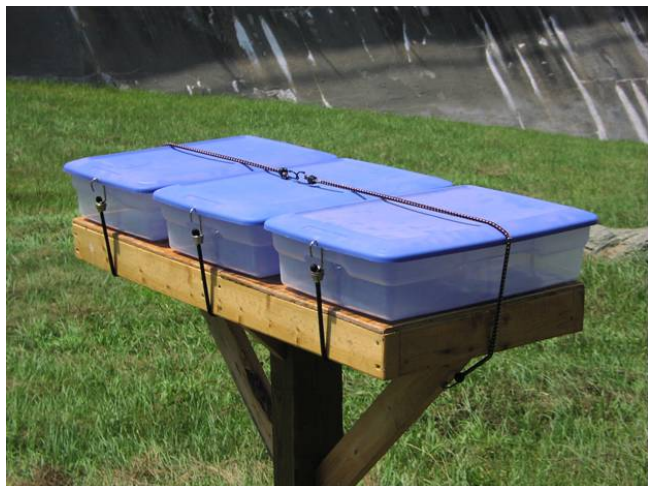
F. X. Browne, Inc. researched methods of atmospheric deposition sampling and designed a sample collection unit based on that research. The collection unit was built using a wooden stand and a set of plastic containers with lids that could be removed as needed. A detailed set of guidelines for sampling were developed and sample collection was coordinated with LWWMD representatives. The sampling unit was constructed near the PPL Superintendent's office. The sampler was destroyed during the construction of the PPL Learning Center and had to be rebuilt. Photos of the sampler are shown below.

**Atmospheric monitoring sampler**

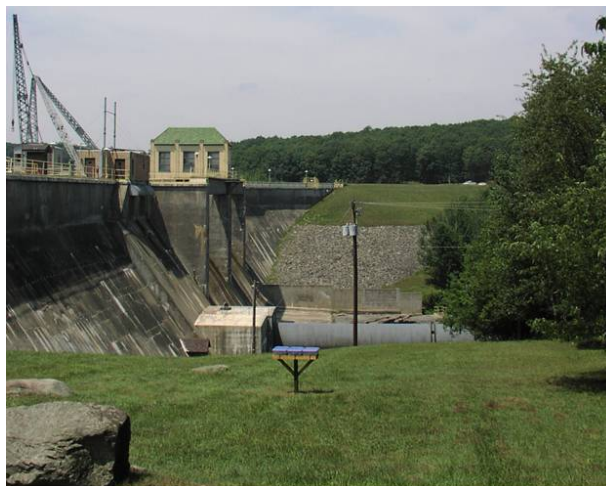
**Atmospheric monitoring sampler at PPL**

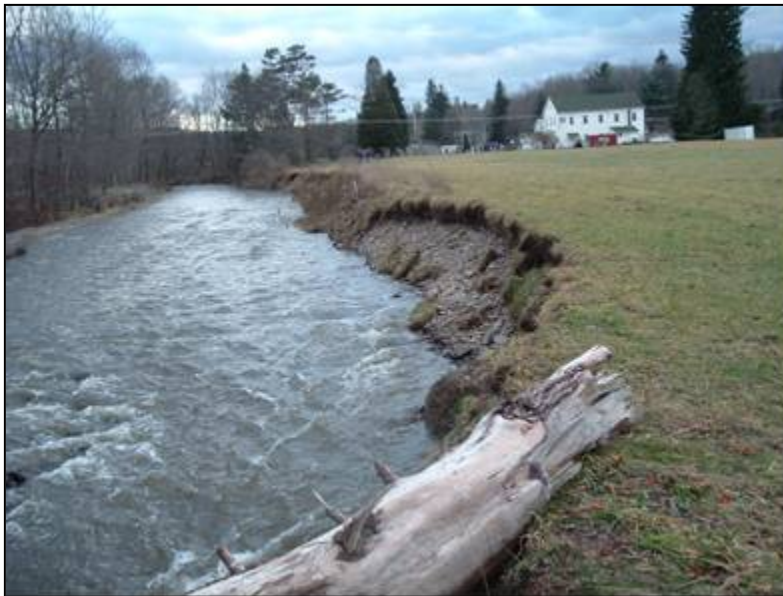
**Nonpoint source problem area #52  
Streambank is in need of restoration**

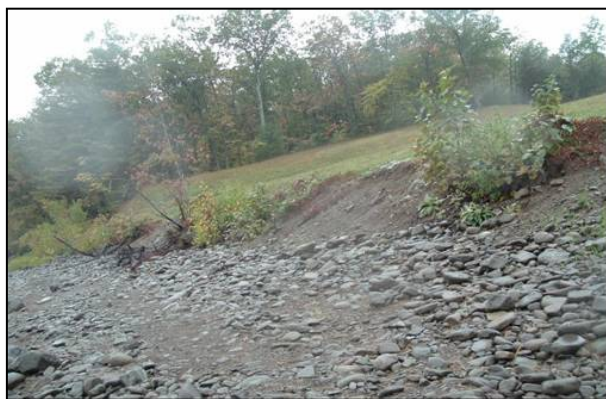
Mangan Cove shoreline erosion project before stabilization

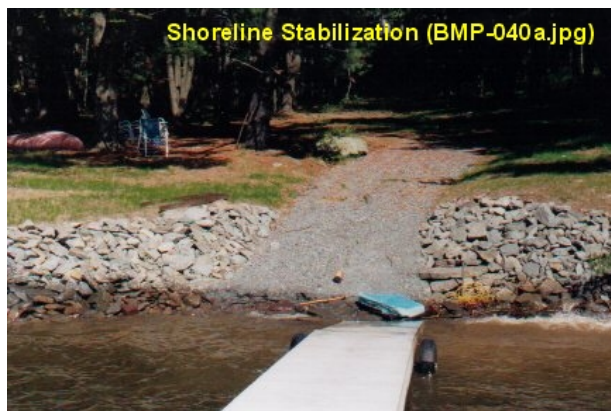
Shoreline erosion stabilization and stable boat access at Kingston property
